**SAS Superstructure**

Daily Diary Report by Bid Item

Contract No.: 04-0120F4

Diary #: 104 Const Calendar Day: 638 Date: 08-Jun-2011 Wednesday

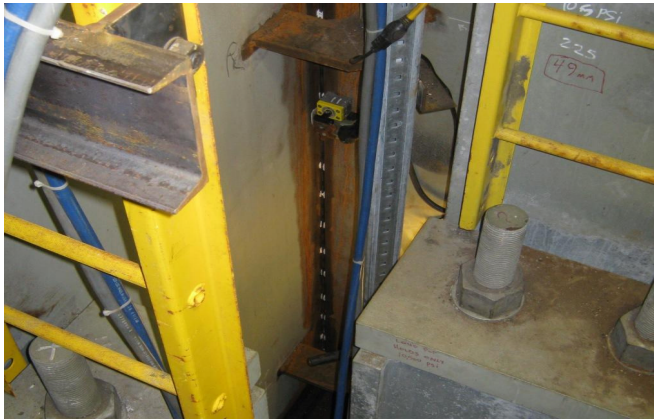
ESW weld joint with consumable guide & insulators installed

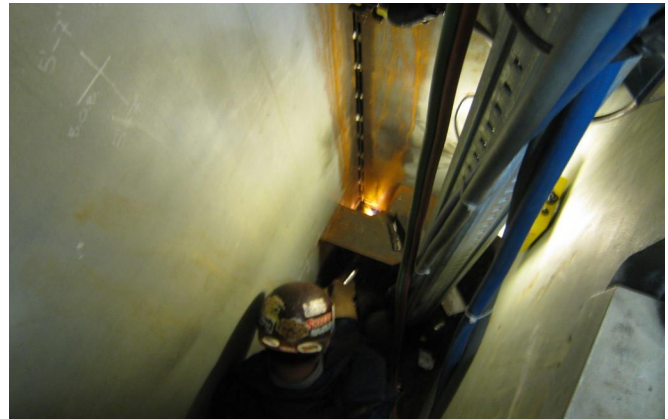
- The ESW equipment was set up at Elevation 13m.
- 2 new barrels of weld wire were brought to the site and connected.
- There was some condensation near the starting sump, so a torch was used to heat the local area to remove the condensation (see attached photo).
- At 09:30, the consumable guide was installed.
- From 09:30 until 11:30, the insulators, volt pick-ups, and cooling shoes were installed.
- At 13:05, the weld was started.
- It took about 2 minutes, 20 seconds for the weld parameters to stabilize.
- At 16:54, the weld ran low on flux for about 1 minute.
- At 18:17, the weld ran low on flux, but it was already up into the run-off tab area.
- At 18:19, the weld was stopped in the run-off area.

Torch heating the starting sump area to remove condensation prior to starting the weld
